Manhole Inspection Summary

Manhole # S11CC2003MH

Insp Date: **7/18/06 9:19 AM**

Location Address: **2406 CREST RD** Cross Street: **ROCKSPRING RD**

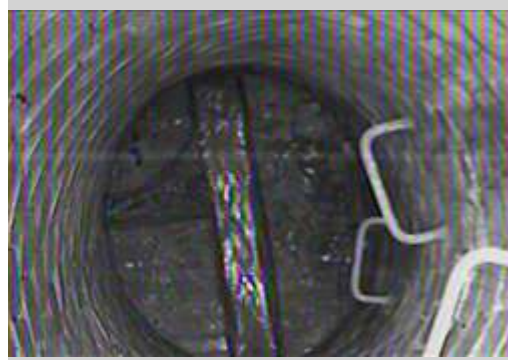
Top View

Bench ☒ Exists Material: **Brick** ☐ Parged ☒ **Debris** (not Condition related)
Condition: ☒ Sound ☐ Cracked ☐ Root Intrusion ☐ Deteriorated ☐ Leaks ☐ Debris

Surcharge ☒ **Evidence Of Surcharge** Depth: **1** (ft.) ☐ Active Surcharge Present

Evidence of surcharge - Bench debris.

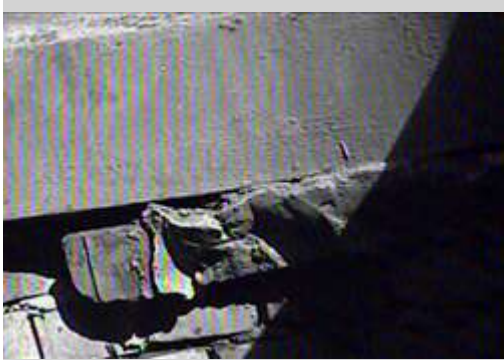
Defect

Frame Offset: **0** (in.) Condition: ☐ Sound ☐ Cracked ☒ **Leaks**

Chimney / Frame Adjustment ☒ Exists Material: **Brick** ☐ Parged Height: **6** (in.)
Condition: ☐ Sound ☐ Cracked ☐ Root Intrusion ☐ Loose Brick ☒ **Deteriorated**
Infiltration: ☐ None ☒ **Joint** ☐ Cracks ☒ **Mortar** ☐ Roots ☐ Wall

Frame leaks. Adjustment deterioration and infiltration.

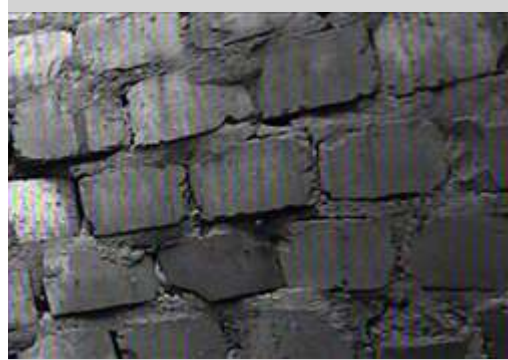
Defect

Corbel Material: **Brick** ☐ Parged Type: **Concentric/Eccentric**
Condition: ☐ Sound ☐ Cracked ☐ Root Intrusion ☐ Loose Brick ☒ **Deteriorated**
Infiltration: ☐ None ☐ Joint ☐ Cracks ☒ **Mortar** ☐ Roots ☒ **Wall**

Corbel deterioration and infiltration.

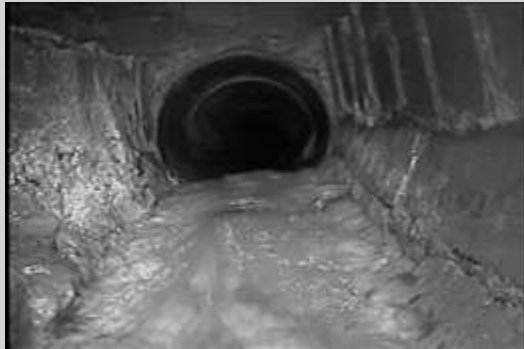
8 in. Circular Gravity Sewer Pipe Out @ 12 O'Clock

Infiltration: **Evidence** Pipe Seal Cond: **Cracked**

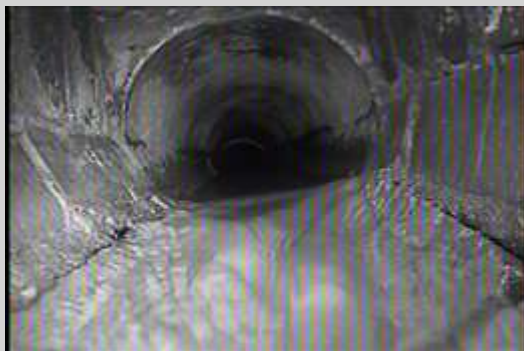
8 in. Circular Gravity Sewer Pipe In @ 6 O'Clock

Channel Material: **Brick** ☐ Parged ☐ Debris (not Condition related)
Channel Exposure: **Fully Open** Junc Dist: **0** nearest .5 ft. Azimuth:
Condition: ☐ Sound ☐ Cracked ☐ Root Intrusion ☒ **Deteriorated** ☐ Leaks ☐ Debris

Channel deterioration.
